**DEVELOPMENT AND INFRASTRUCTURE SERVICES INFORMATION REPORT  
ENGINEERING SERVICES 2016-19**

TO: Mayor and Members of Council  
SUBJECT: Rubberized Sidewalks- Pilot Project – Two Year Follow-Up Report  
ORIGIN: Commissioner of Development & Infrastructure Services

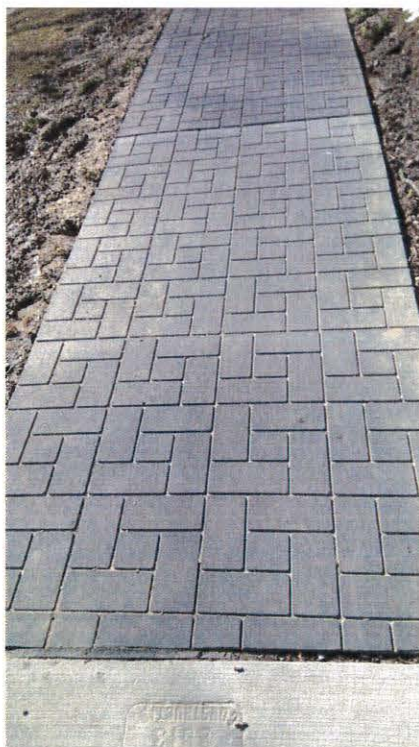
Recently, Engineering Services staff inspected the remaining locations and found that, while the section in front of 178 Victoria Street stood up quite well to normal wear and tear that included snow clearing and seasonal freeze-thaw cycles, the other two locations displayed signs of failure. At the London Road location, the rubberized sidewalk was broken in places, had heaved and sunk in sections and was found to be otherwise substandard, creating a potential hazard for pedestrians. Similarly, at the Queen Street location, the rubberized sidewalk settled unevenly, causing water ponding and ice formation under fall and winter conditions. Several toe trips developed as well, creating a potential pedestrian hazard.
