**A REPORT TO
MILLFORD DEVELOPMENT LIMITED**

PHASE I ENVIRONMENTAL SITE ASSESSMENT

PROPOSED RESIDENTIAL DEVELOPMENT

Reference No. 0907-E017

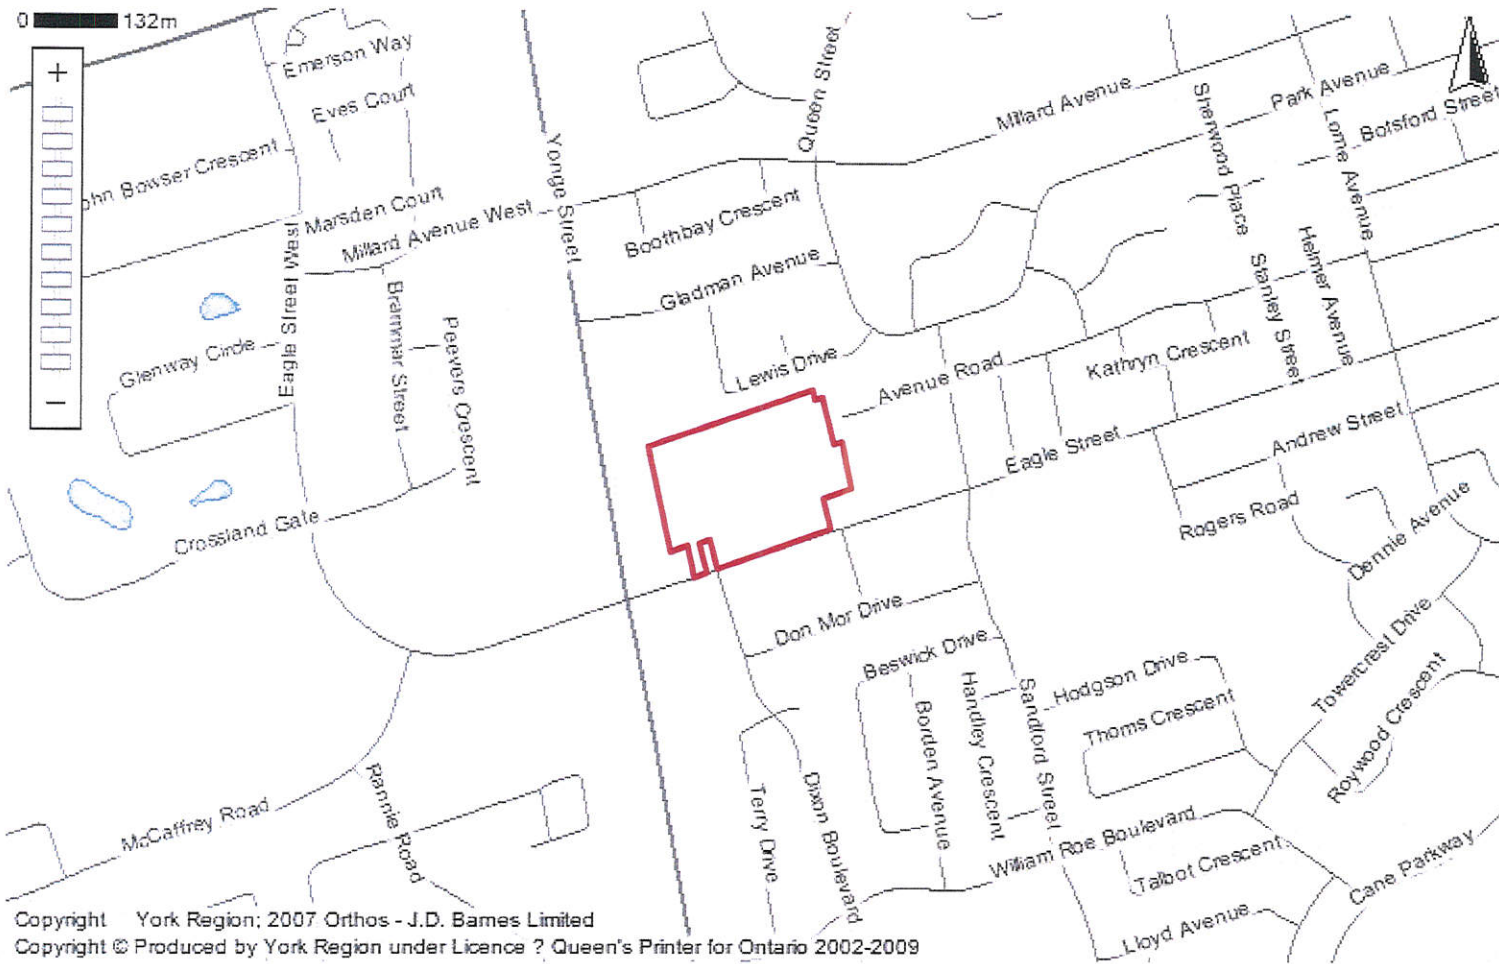
Title	Site Location Plan
Project	Proposed Residential Development North of Eagle Street and east of Yonge Street Town of Newmarket
Reference No.	0907-E017
Date	July 21, 2009
Scale	See Map
Drawing No.	1

The subject property, as shown on the Site Location Plan, Drawing No. 1, is located north of Eagle Street and east of Yonge Street in the Town of Newmarket. The Property Identification Number (PIN) is 0309, as shown on the Property Index Map (Block 03598), Drawing No. 2.

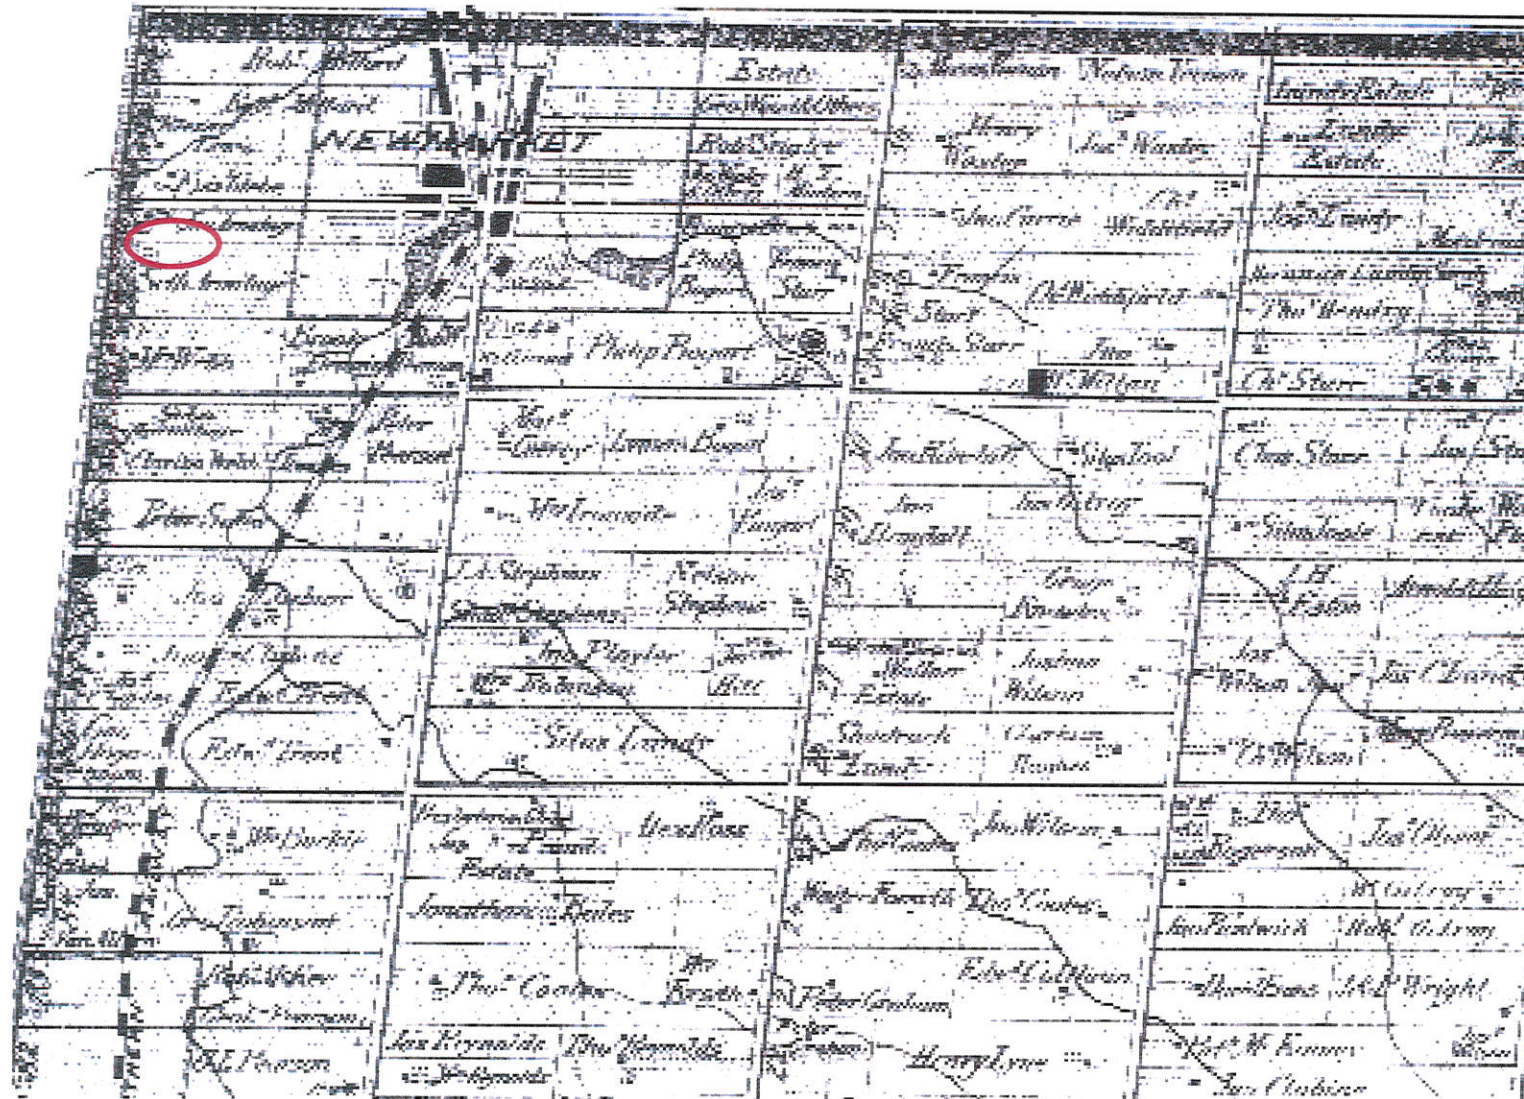
Title	1878 Historical Map
Project	Proposed Residential Development North of Eagle Street and east of Yonge Street Town of Newmarket
Reference No.	0907-E017
Date	July 21, 2009
Scale	NTS
Drawing No.	4

A Historical Map drafted in 1878 was located at the Soil Engineers Ltd. reference library. A copy of the map is presented on Drawing No. 4, showing the subject site was part of the estate owned by John Armitage. Given the size and shape of the estate, it appears to have been used as farmland at that time.

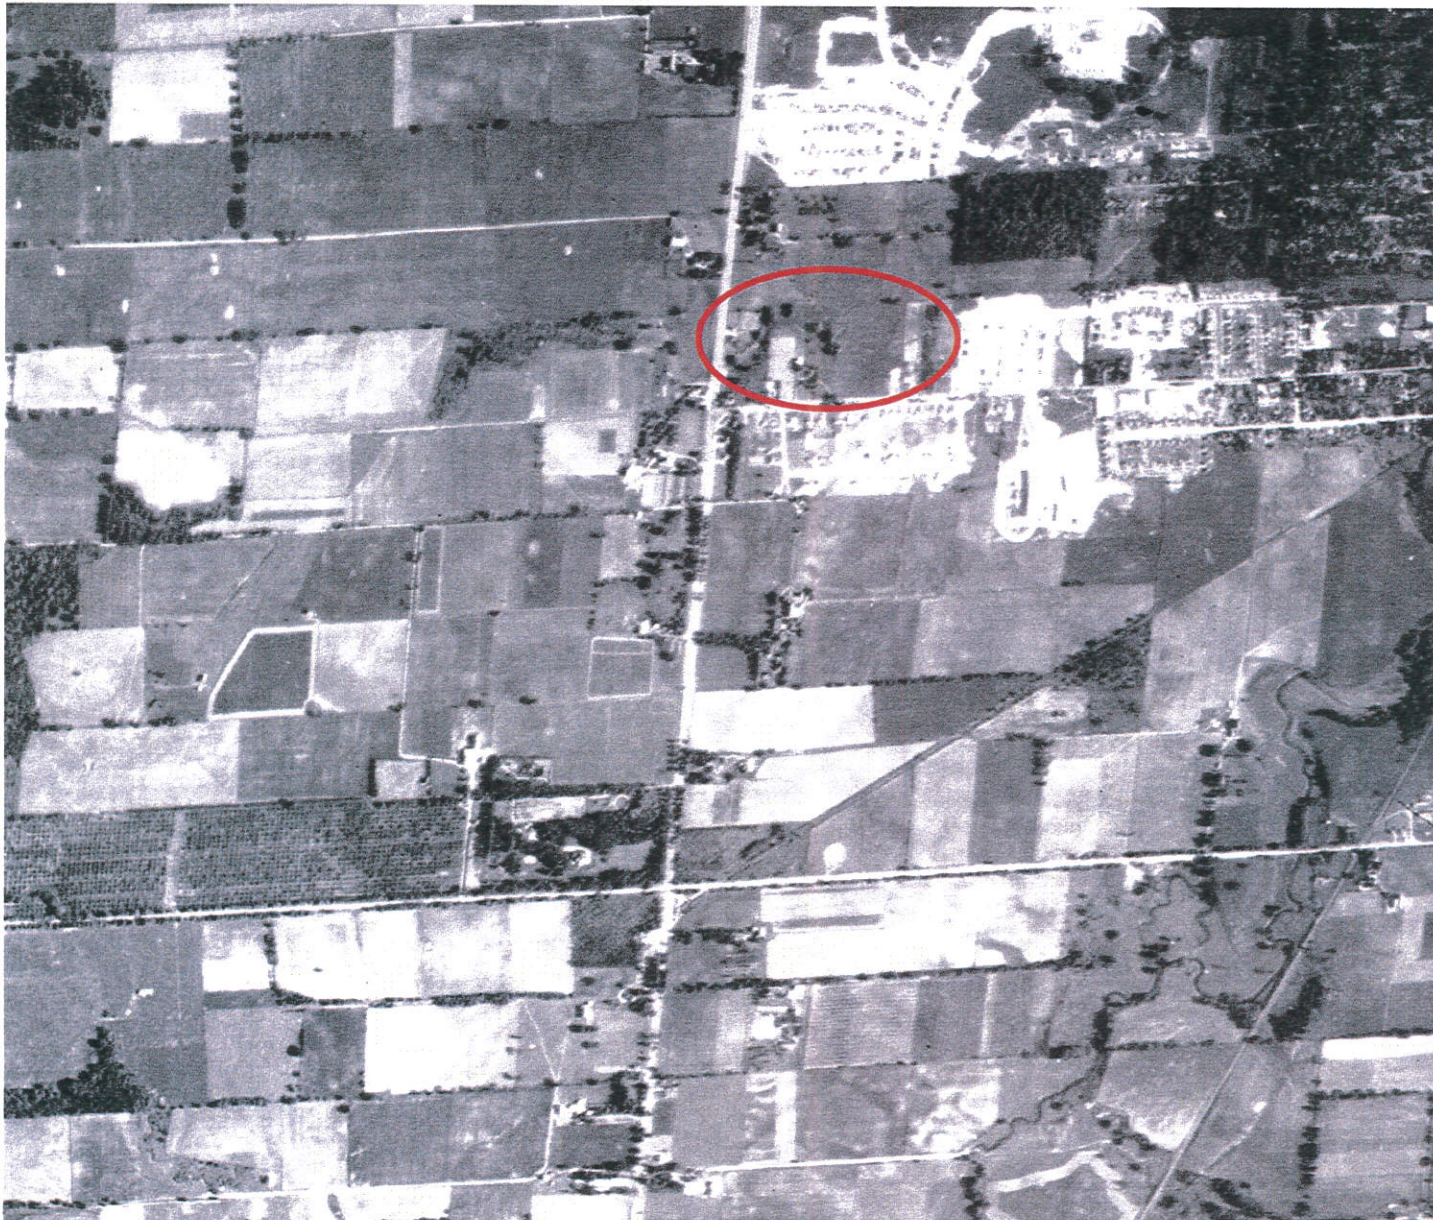
Title	1955 Aerial Photograph
Project	Proposed Residential Development North of Eagle Street and east of Yonge Street Town of Newmarket
Reference No.	0907-E017
Date	July 21, 2009
Scale	NTS
Appendix 'A'	Page 1 of 8

Aerial photographs dated 1955, 1969, 1975, 1985, 1995, 2002, 2005 and 2007 were reviewed at York Region website and the Natural Resources Canada National Air Photo Library. The photographs indicate that the site and surrounding areas appeared to have been developed with residences in 1955, with agricultural lands surrounding the residences. The 1969 photograph shows residential development to the northeast of the site. The structure that was present on the site appears to have been demolished by 1975, and the site has been vacant since that time. Copies of the aerial photographs are presented in Appendix 'A'.
